TROUBLESHOOTING MONO ETHYLENE GLYCOL CARRYOVER IN A CANADIAN GAS PLANT¹

Laurance Reid Gas Condition Conference
February 26th – March 1st, 2019 – Norman, Oklahoma USA

TROUBLESHOOTING MONO ETHYLENE GLYCOL CARRYOVER IN A CANADIAN GAS PLANT

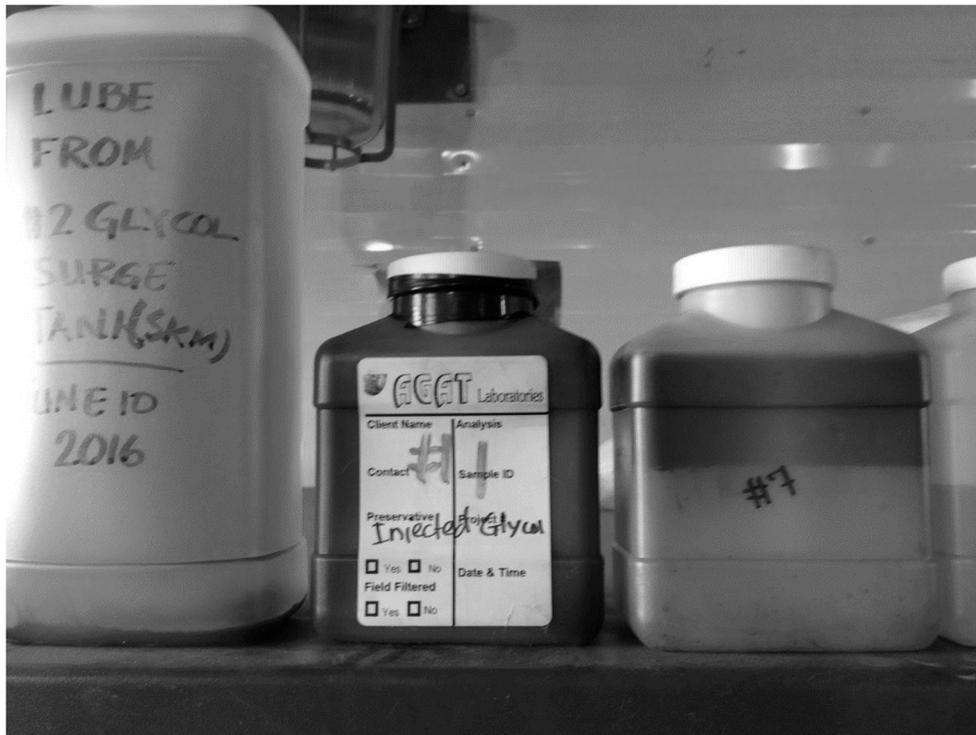
After the plant was commissioned in the fall of 2013, the MEG refrigeration processes began experiencing operational issues at 60% of the design throughput capacity. Initially, lube oil carry-over from second stage compression caused fouling of the tubes in the gas-to-gas exchangers and chillers. This was caused by a compressor oil which was heavier than specified in the original design. The lube oil was injected in the first and second stages of the reciprocating compressors and carried into the refrigeration train. Since the lube oil was heavier than glycol, it accumulated in the glycol closed loop system. The lack of process coalescers after second stage compression meant no barrier existed against contaminant ingress into the refrigeration trains. Operations addressed this in the summer of 2015 by installing process coalescers upstream of the refrigeration trains and changing out the lube oil. This resolved the lube oil carryover/fouling in the refrigeration units .

Figure 3 - MEG samples prior to process coalescer installation. Lube oil sample (left), Injected Glycol (centre), skimmed Glycol from flash tank (Right). Prior to June 2015

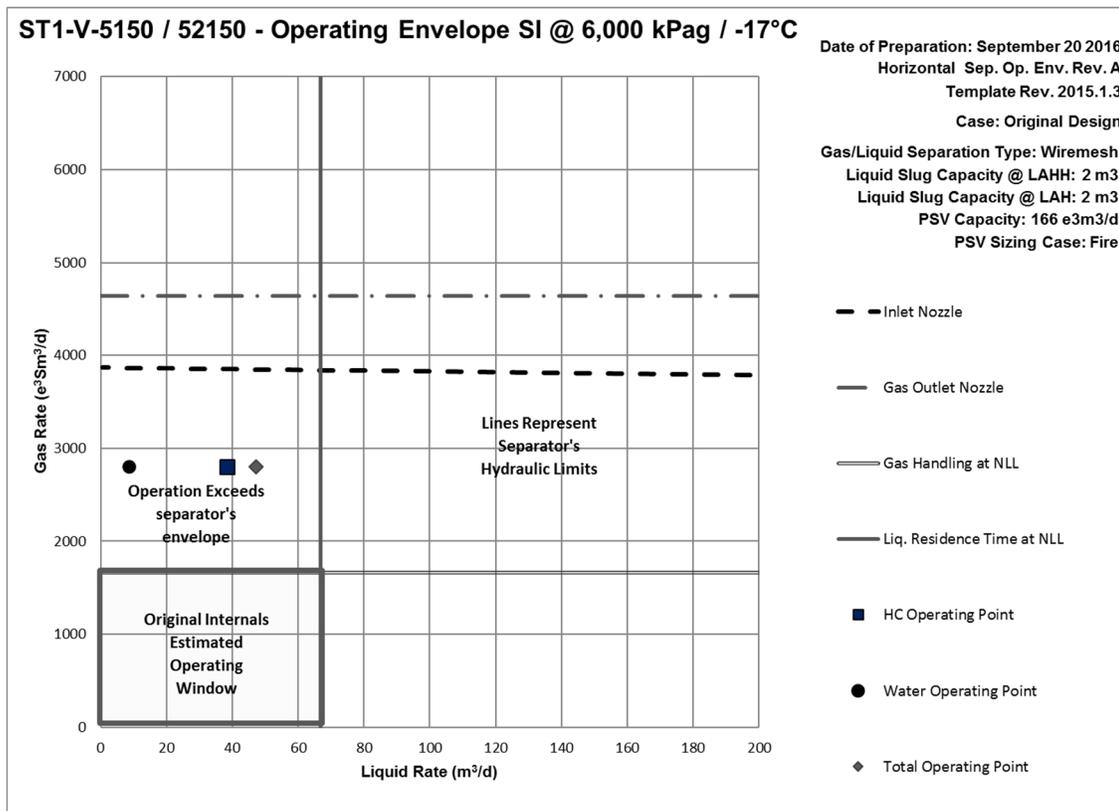
After the coalescers were installed, liquid carry over made out of mostly MEG/water through the refrigeration trains was noticed, especially when the flowrate exceeded 60% of the design capacity per train. As a result a root cause analysis (RCA) was requested by the leadership team. The RCA was completed in the winter of 2015 with the participation of the Process Engineering team based in Calgary. The findings of this RCA showed that the internals of the LTS were undersized, and modifications to the inlet device and demisting pad were recommended to prevent excessive liquid carryover. The original LTS operating envelope can be seen in Figure 4. The original design had a diverting plate as inlet device and a standard horizontal mesh pad at the outlet. This was changed to 4 inlet cyclonic devices and a combination of vertical mesh pad/vane pack arrangement. In addition, process simulations showed that the glycol injection rates to the refrigeration exchangers were below the required theoretical minimum, and an increase was recommended. Evidence of the liquid carryover was first spotted due to substantial glycol losses and liquids present in the gas header downstream of the refrigeration trains.

Figure 4 - Simplified LTS Operating Envelope prior to retrofit illustrating different mechanical constraints prior to Q2 2016. Operation exceeds maximum capacity of the separator internals

Following the recommendations of the Process Team and the EPC contractor outlined in the RCA, the internals of the LTS in both trains were upgraded to a cyclonic inlet separation device and larger vertical mesh pad and vane pack combination, replacing the horizontal mesh pad, during a pit stop in the summer of 2016. After these changes, liquid carryover and first stain did not improve, as Operations continued to see liquid in the gas header and sales coalescer, as well as stains during Chilled Mirror testing between 0 °C to 5 °C (32 °F to 41 °F).

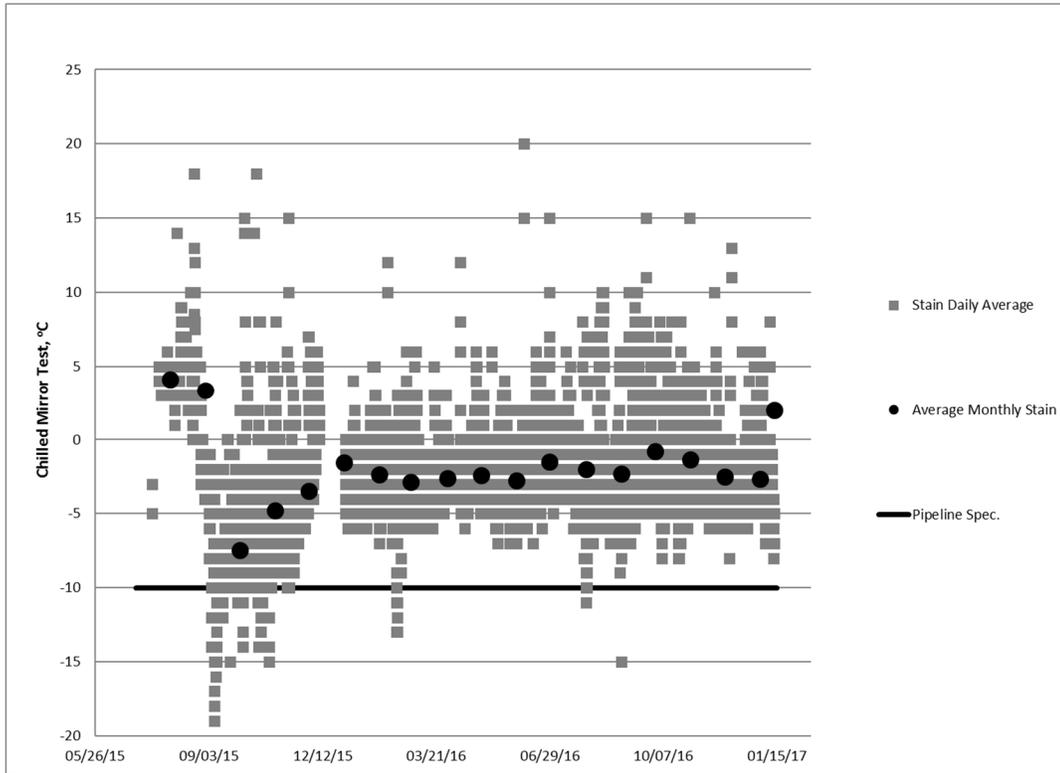
Chilled Mirror tests, or Chandler tests, resulted in a "stain" appearing at temperatures as high as 10 °C (50 °F). This "stain" caused the HCDP test to be considered a failure by the pipeline company. Research has demonstrated that the Chilled Mirror test can be skewed by even trace amounts of MEG (Mono Ethylene Glycol) present in the gas stream (Lokken, 2013) (Lokken, 2012).

Figure 5 - Chilled Mirror Daily and Monthly Average Results vs. Pipeline Specification from 2013 to Q2 2017

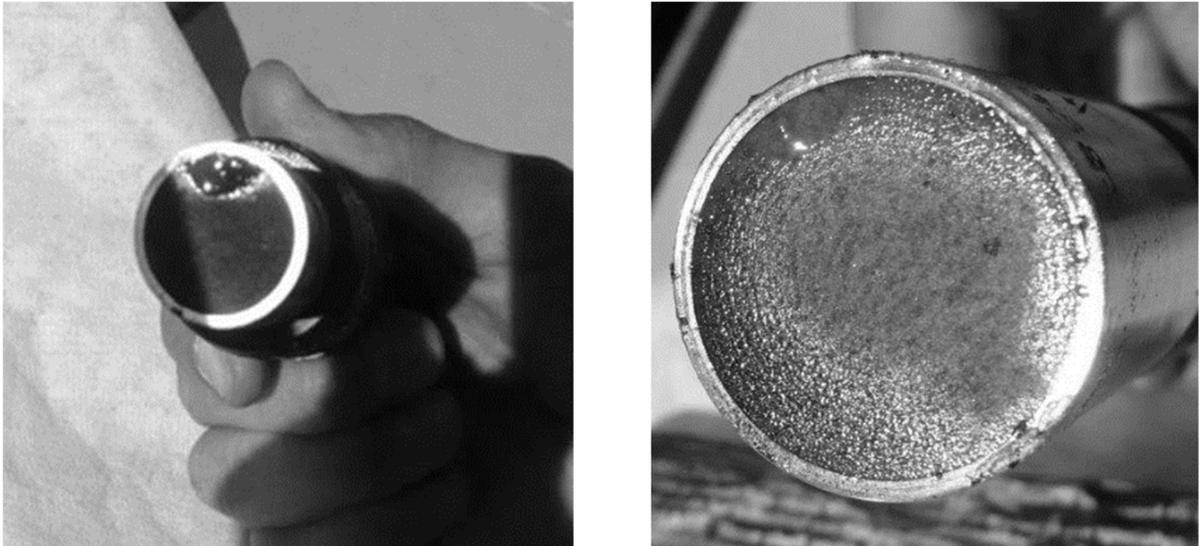
Further investigation by the Process team found that additional operating changes were completed prior to the summer of 2016 with the aim to reduce liquid carryover. MEG injection to the gas-to-gas exchangers was reduced and MEG injection to the chiller was eliminated. These changes led to hydrate formation in the units. In addition, a Management of Change (MOC) completed by Operations reduced the size of the random packing in the glycol regeneration column with the goal of increased capacity and efficiency; however, no hydraulic or process calculations were completed to support this change and its potential consequences. Remote monitoring and troubleshooting of the plant by support teams was also difficult due to the lack of access to the plant historian data outside the facility.

Figure 6 - Chilled Mirror test “stain” as observed at sales point from 2013 to Q2 2017

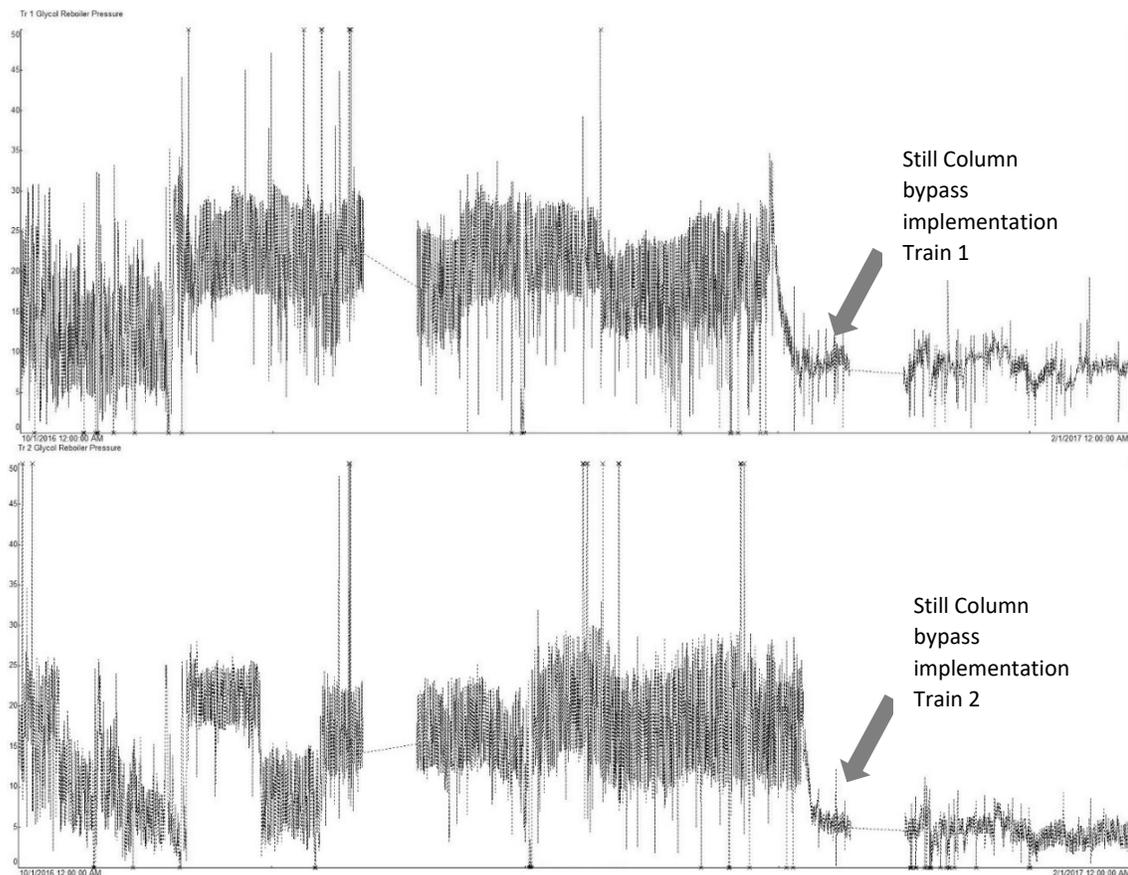
After the nozzle replacements, there was confidence that the glycol injection rates could be ramped up to recommended values; however, a dramatic increase in the still packed column pressure showed that flooding was taking place. Glycol samples from the bottom of the still overheads condenser/separator showed that it had a MEG concentration as high as 58 wt.% - in normal operation it should be mostly water. Hydraulic calculations confirmed that the column was grossly undersized for the service after the MOC implementation for random pall ring packing changeout from the original 1" to 5/8". In a survey of other regeneration units from other plants and standard vendor skids showed that the existing 8" columns for a 100MMSCFD train were too small. Typical vendor designs called for 12" to 14" columns for a similar train capacity. To address this problem, the glycol feed line to the middle of the columns were partially re-routed directly to the reboiler. This modification helped to reduce glycol losses, eliminated the flooding condition in the column, and still achieved the desired lean glycol concentration. The difference in still column pressure before and after this modification can be seen below in Figure 7. Despite the above modifications, liquid carryover to the sales gas continued.

Figure 7 - Glycol regeneration still column pressure (Train 1 above, Train 2 Below) before and after bypass installation in Q4 2016

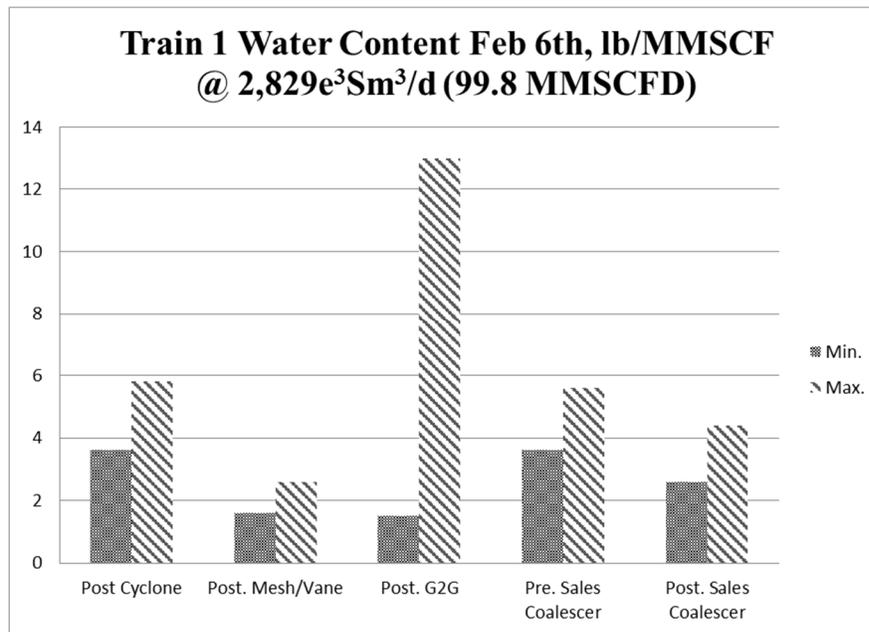
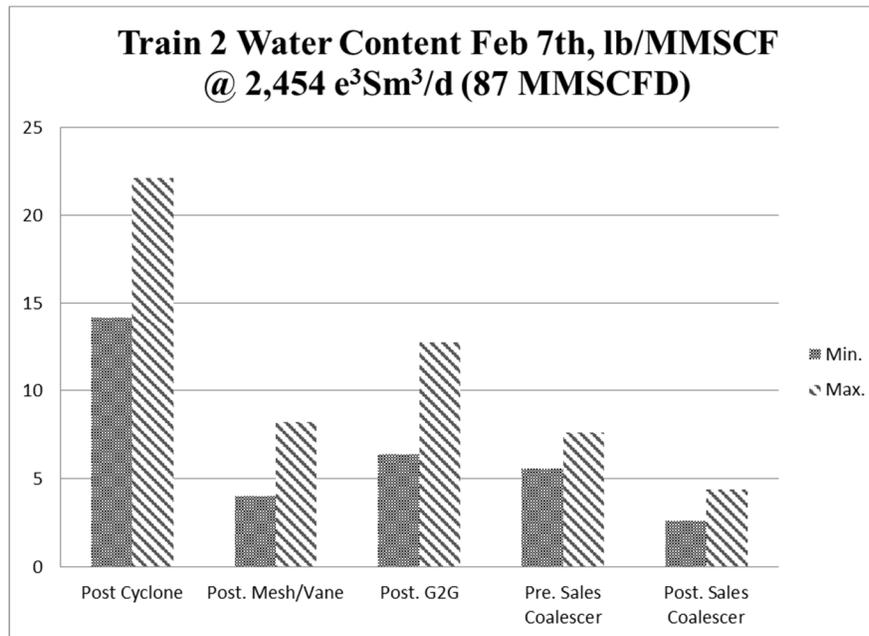
Figure 8 - Water Content Results Pre-Turnaround for both Trains in Q1 2017

The water content values at sample points downstream of the Mesh/Vane pack further backed up the theory that there were leaks in the gas-to-gas exchangers. At this point of the investigation, a key piece of information was shared that the original mesh pads were found collapsed during inspection in 2015 as illustrated in Figure 9. The failure appeared to coincide approximately when glycol injection rates were cut below recommended/simulated values. Unfortunately, it was a missed opportunity to check if there was a leak at that time because the exchangers were not inspected during the LTS internals upgrade, as mentioned previously. This information provided further support for possible tube damage and emphasized the importance of an exchanger inspection during the turnaround. During the scheduled plant turnaround in Q2 2017, the exchangers, chillers, and LTS were inspected, similarly the

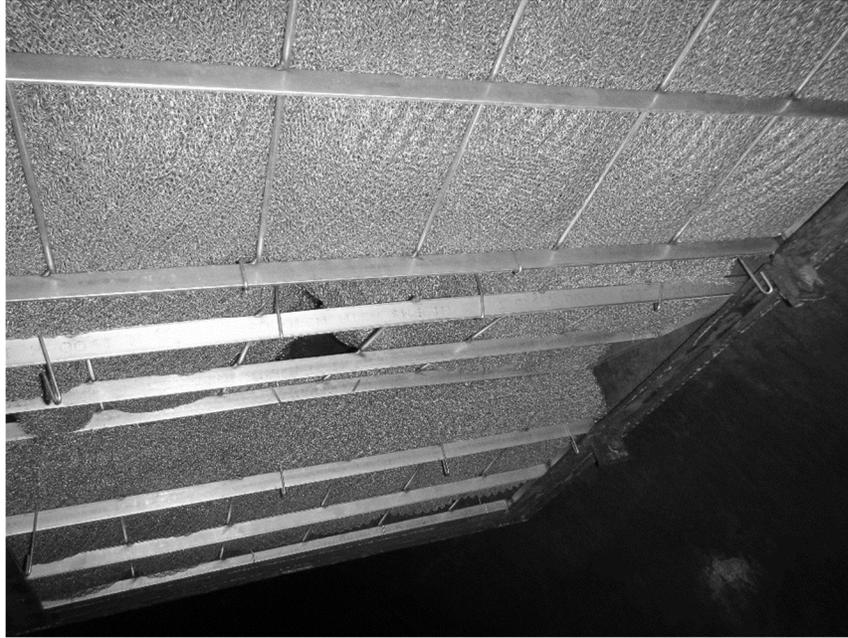
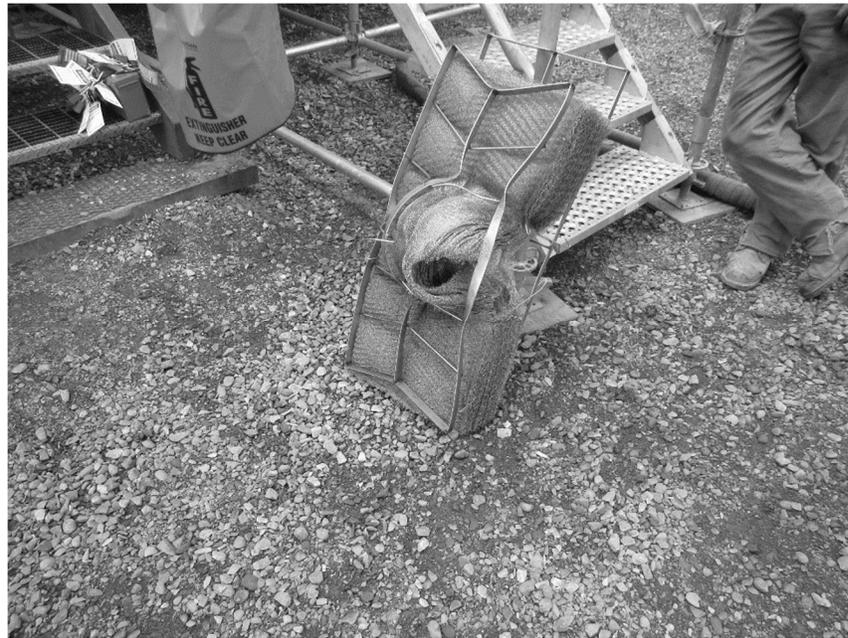
Figure 9 - LTS Failed Mesh pads as found during LTS internals replacement in Q2 2016

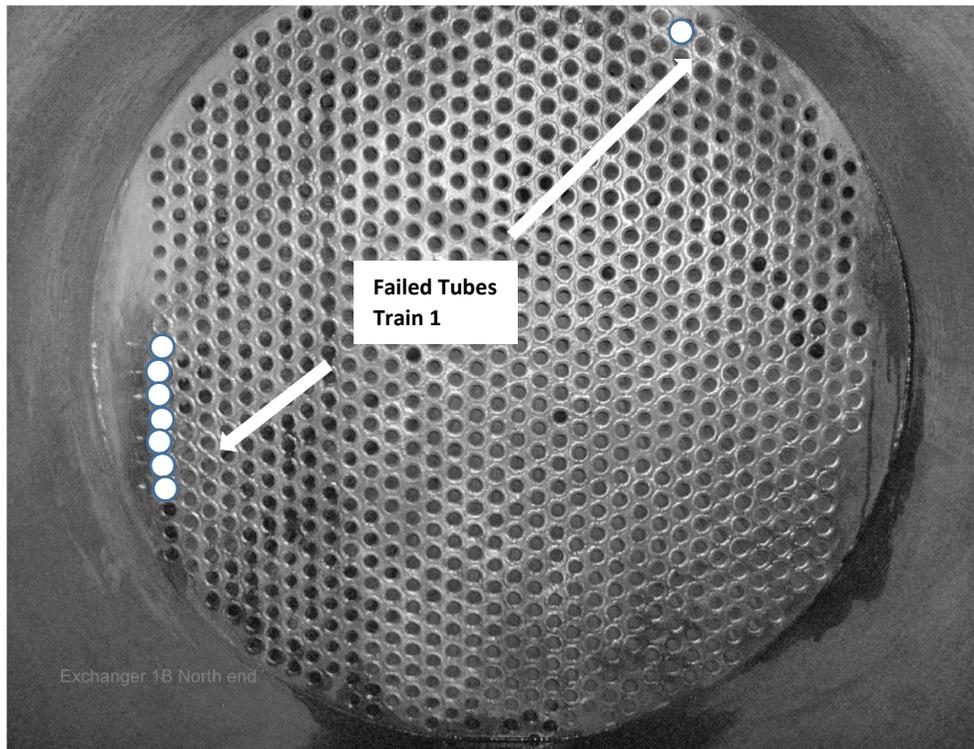
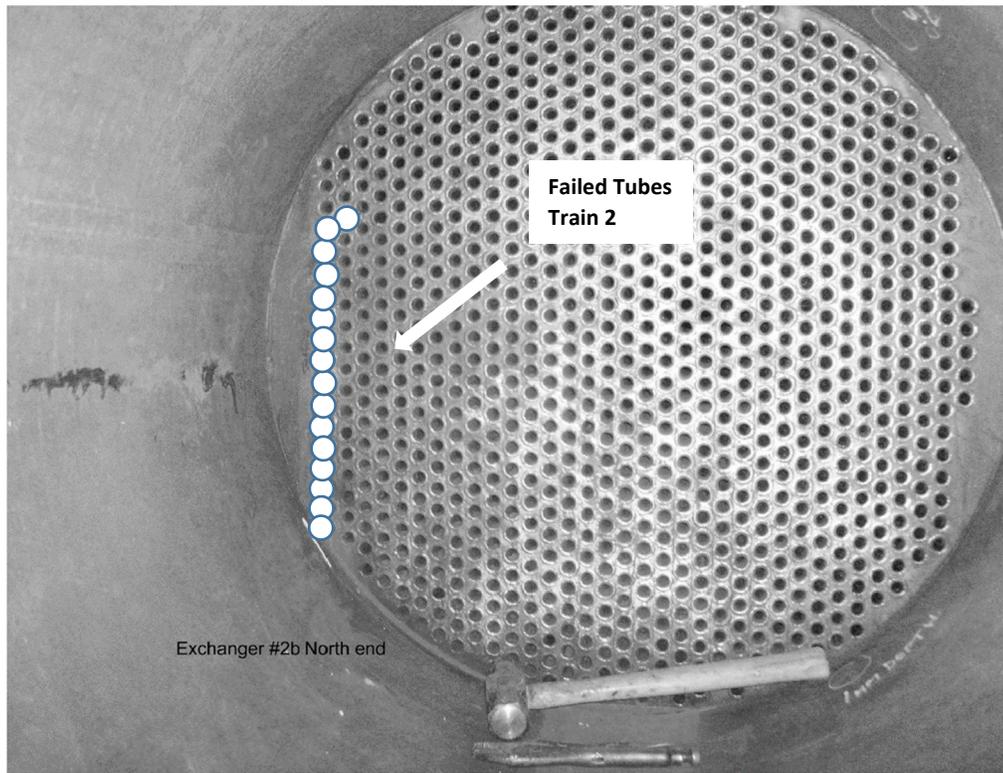
A water leak test was followed by visual inspection of the gas-to-gas exchangers revealed several ruptured tubes on the second pass exchangers where the cold sales gas enters from the LTS. These are 5/8” OD 16 BWG welded tubes, the site inspections team confirmed that most of tube failures were at first row of tubes at shell inlet on first pass from the Low Temperature Separator, second pass from inlet process coalescer heat exchanger in series of each train. The inspection identified eight failed tubes in Train 1 and sixteen in Train 2 as shown in Figure 10. All tubes at nozzle inlet were sheared at the back side of the tube sheet. This was consistent

with the likelihood of impact failure due to dislodged hydrates from the original LTS mesh pads. There was however one tube that failed on the opposite end of the nozzle. An illustration and photograph of the damaged tube locations can be seen below in Figure 10. To understand the cause for the tube failures, an HTRI model was set up by the heat transfer group. However, the vendor data sheet and mechanical drawings were incomplete, and the vendor did not supply the missing information upon request. This made the troubleshooting more difficult and Tubular Exchanger Manufacturers Association (TEMA) guidelines were used to fill in the blanks.

Figure 10 - Train 1 (top) and Train 2 (bottom) Gas-to-Gas 2nd Pass Tube Failures as found during Turnaround in Q2 2017

The HTRI evaluation indicated vibration warning messages for the shell entrance, tube bundle entrance velocity and cross velocity into bundle were flagged for excessive vibration in the heat exchangers. High velocity predictions were calculated at normal gas flow rates with mechanical vibration being quite high on the partially supported and close to the impingement plate tubes on the shell side. This could lead to fretting type failure (tubes hitting each other). However, a more detailed mechanical inspection of the exchangers was not possible due to turnaround time constraints. The gas to gas exchangers are TEMA NEN which have their tubes sheets welded to the shell and to gain access to the shell inlet nozzles for inspection it required a great deal of time and effort to remove the piping attached to them leading to an extended turnaround e.g. scaffolding, cranes etc. A maximum gas flow limit was issued to Operations as well as guidelines of things to look for if something similar happens in the future, the failed tubes on both trains were plug welded and hydrotested during the turnaround.

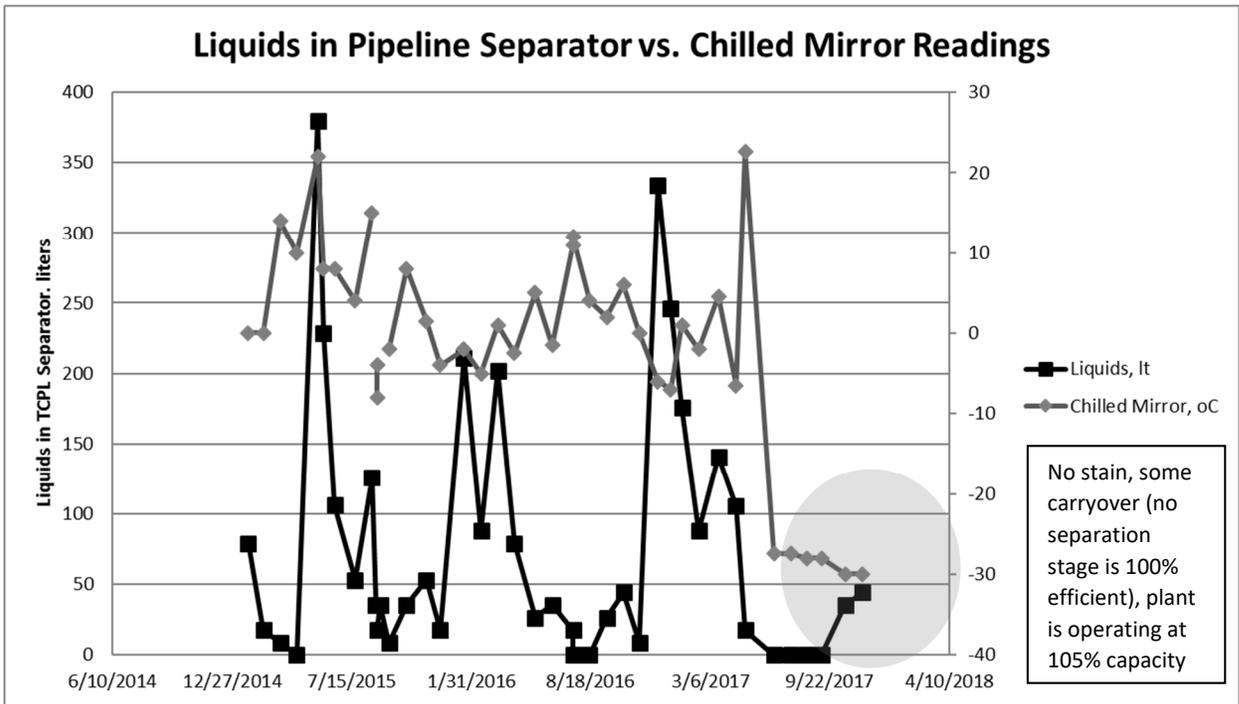
Figure 11 - TCPL Scrubber Liquids Pre/Post Turnaround

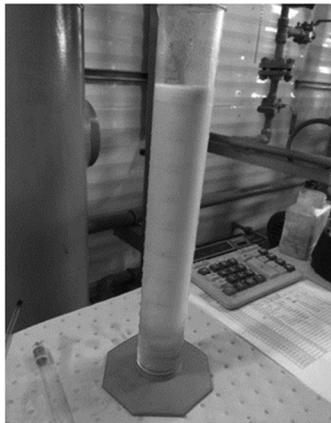
Before – Flash Tank foaming, glycol carryover in flash gas. Carbon beds spent too fast and bypassed, excessive HC to reboiler/still column

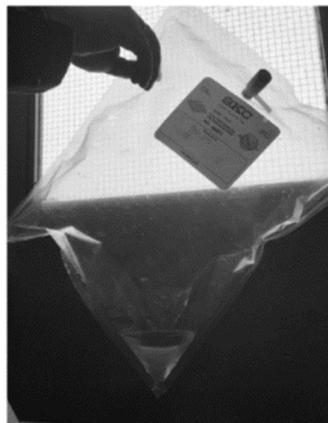
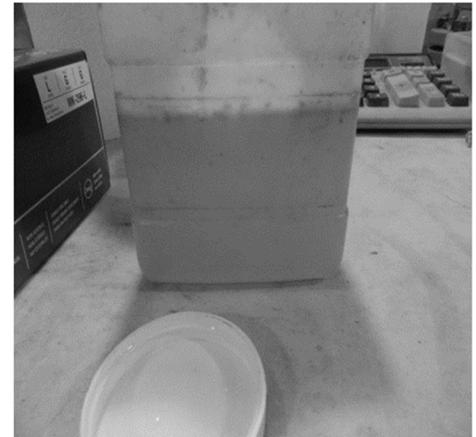
After – Minor foaming/HC to reboiler/still column. Carbon beds online
